Manhole Inspection Summary

Manhole # S25E1_001MH

Insp Date: **4/17/08 11:28 AM**

Location Address: **BEHIND 2437 WESTPORT ST.** Cross Street: **WATERVIEW AV.**

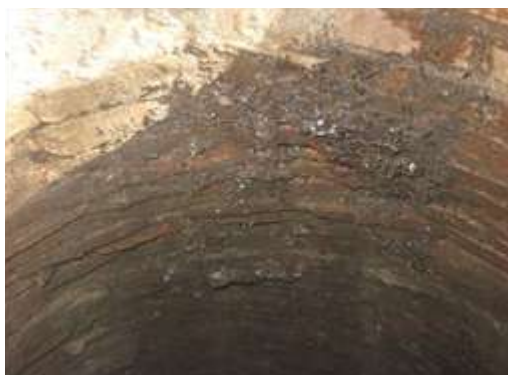
Defect 4

Infiltration: ☐ None ☐ Joint ☐ Cracks ☒ **Mortar** ☐ Roots ☒ **Wall**

EVIDENCE OF BARREL INFILTRATION
AT WALL & MORTAR

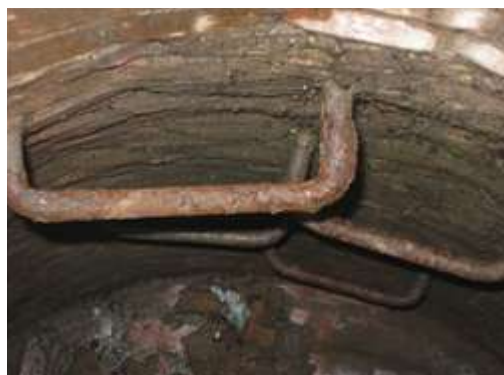
Defect 3

Infiltration: ☐ None ☐ Joint ☐ Cracks ☒ **Mortar** ☐ Roots ☒ **Wall**

Steps Count: **4** Missing: **0** ☒ **Corroded**

CORRODED STEPS AND CORBEL
INFILTRATION AT WALL

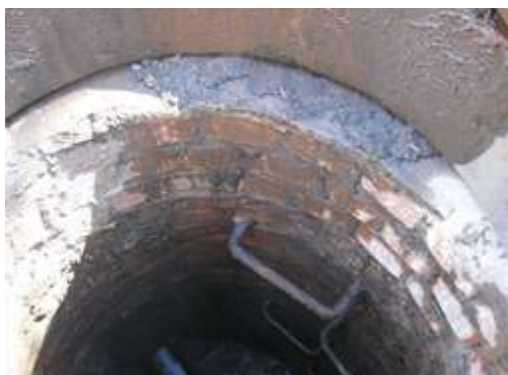
Defect 2

Condition: ☐ Sound ☐ Cracked ☐ Root Intrusion ☒ **Loose Brick** ☐ Deteriorated

Infiltration: ☐ None ☐ Joint ☐ Cracks ☒ **Mortar** ☐ Roots ☐ Wall

MISSING BRICK AND MORTAR WITH
EVIDENCE OF CHIMNEY AND CORBEL
INFILTRATION AT MORTAR

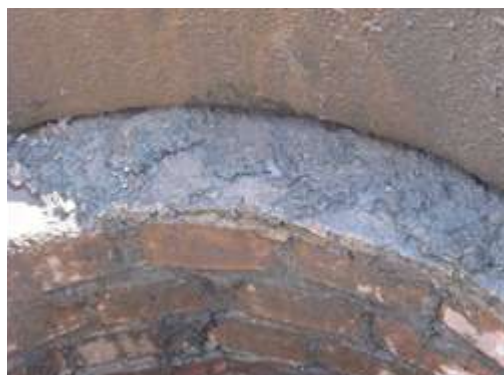
Defect 1

Frame Offset: **1.5** (in.) Condition: ☒ Sound ☐ Cracked ☐ Leaks

2 IN FRAME OFFSET

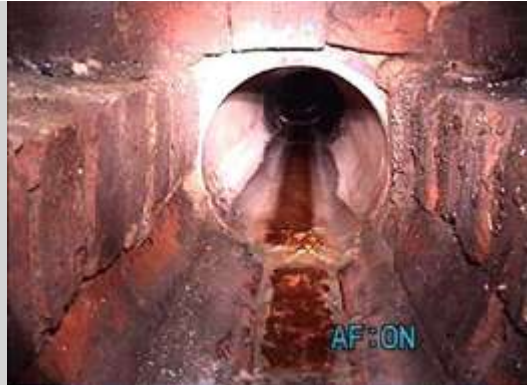
12 O'Clock Outflow

8 in. Circular Gravity Sewer
Pipe Out @ 12 O'Clock

Pipe Height: **8.4** (in.) Rod and Bar (Angled)
Pipe Material: **Clay** ☐ Pipe Lined
Invert Depth: **8.80** (ft.) Flow Characteristics: **None**
Deposits: ☒ None ☐ Mud ☐ Sludge ☐ Debris ☐ Grease
Silt Depth: **0** (in.) Deposits Extent:
Infiltration: **None** Pipe Seal Cond: **Sound**

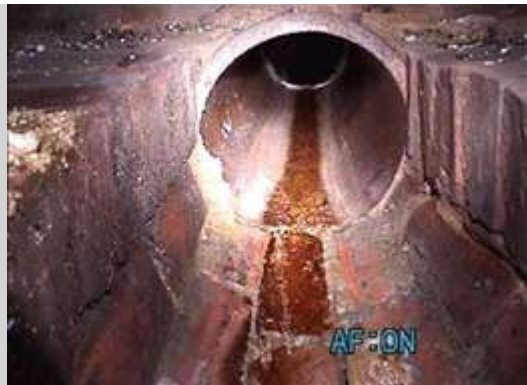
6 O'Clock Inflow

8 in. Circular Gravity Sewer
Pipe In @ 6 O'Clock

Pipe Height: **8.4** (in.) Rod and Bar (Angled)
Pipe Material: **Clay** ☐ Pipe Lined
Invert Depth: **8.85** (ft.) Flow Characteristics: **None**
Deposits: ☒ None ☐ Mud ☐ Sludge ☐ Debris ☐ Grease
Silt Depth: **0** (in.) Deposits Extent:
Infiltration: **None** Pipe Seal Cond: **Sound**
